HOME INSPECTION REPORT

**MICKEY MOUSE
29550 PETUNIA LANE
BIG PINE KEY, FL 33043**

Island Life Inspections
www.IslandLifeInspections.com
IslandLifeInspections@gmail.com
(305) 912-4640
Inspection Performed by Bob Brancheau
Florida State Licensed Home Inspector LIC #HI9799

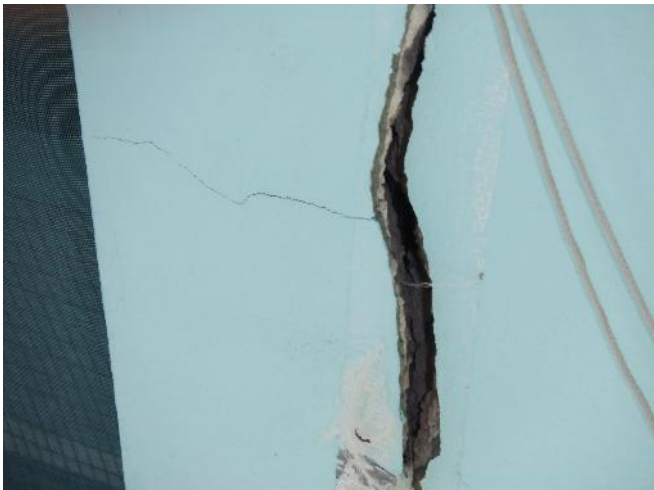
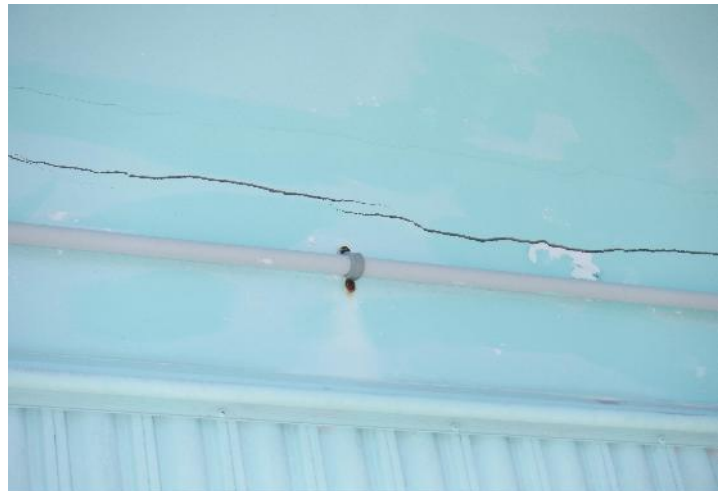
There are signs of spalling around the exterior of the house.

Spalling should be corrected to prevent further damage to the structure.

I recommend that all exposed concrete be sealed with Luxon paint from Sherwin-Williams.

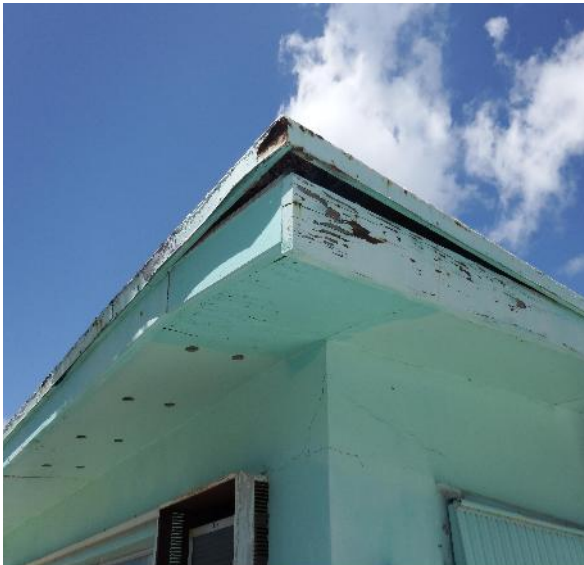
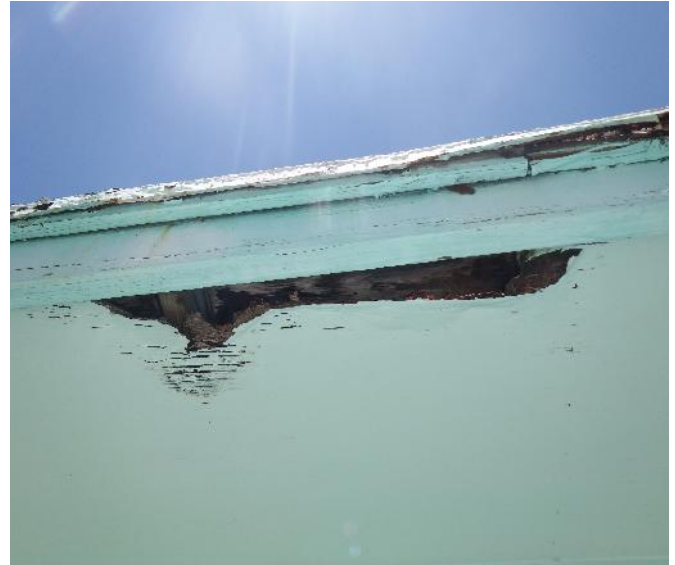
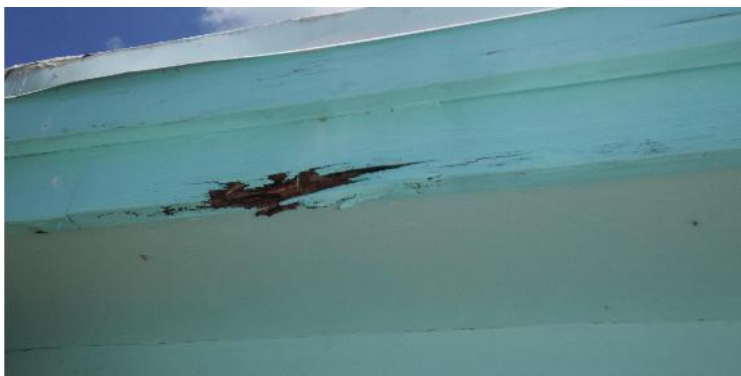
There were signs of rot in the soffit area and fascia.

After spalling repair is complete, seal the exterior with Luxon paint by Sherwin-Williams.

Caulk and seal the cracks to prevent further deterioration.

I recommend you caulk, prime and paint the exterior of the home.

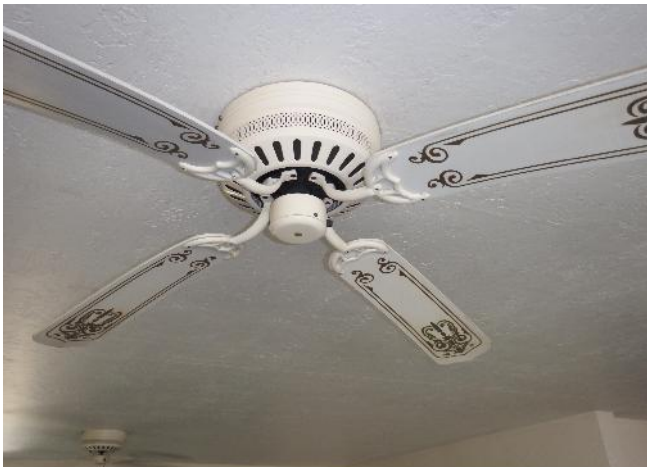
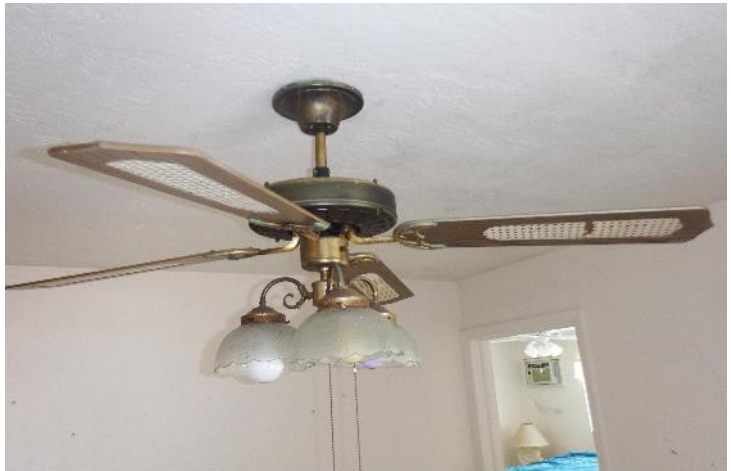
The ceiling fan in the living room needs to be replaced as it did not function.

I recommend replacement of the GFI outlets in kitchen, bathroom and exterior locations.

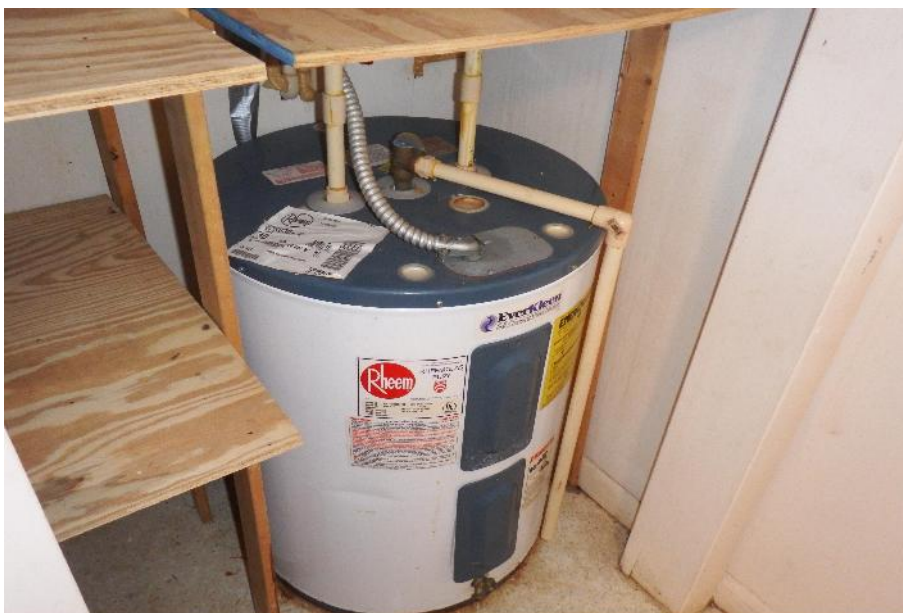
The shut off valve did not work on the water heater

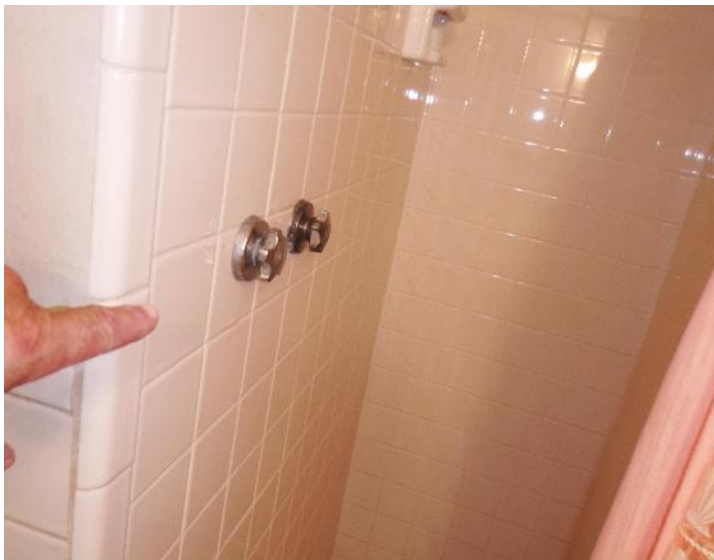
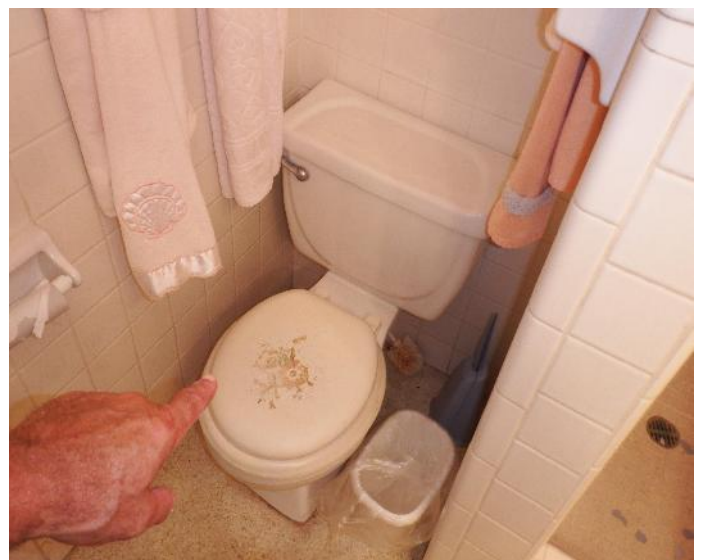
The toilet has come to the end of its useful life. I recommend replacing it with a new ecofriendly toilet.
The faucets in are in need of replacement as they leaked

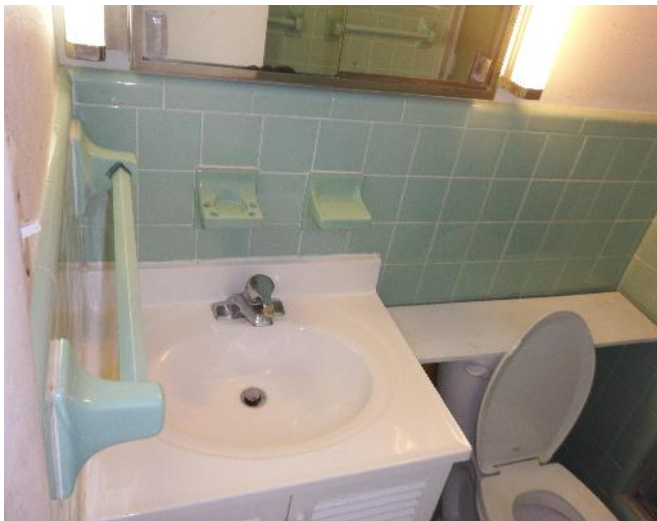
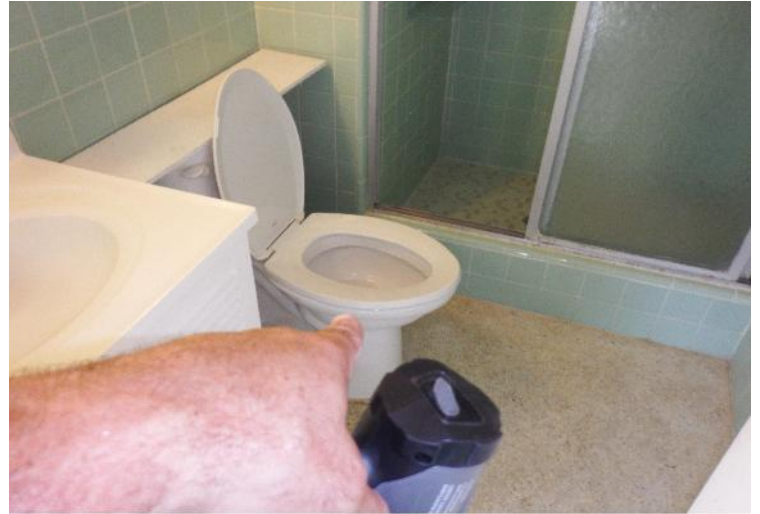
The toilet has come to the end of its useful life. I recommend replacing it with a new ecofriendly toilet.
The faucets were in need of replacement as they leaked.

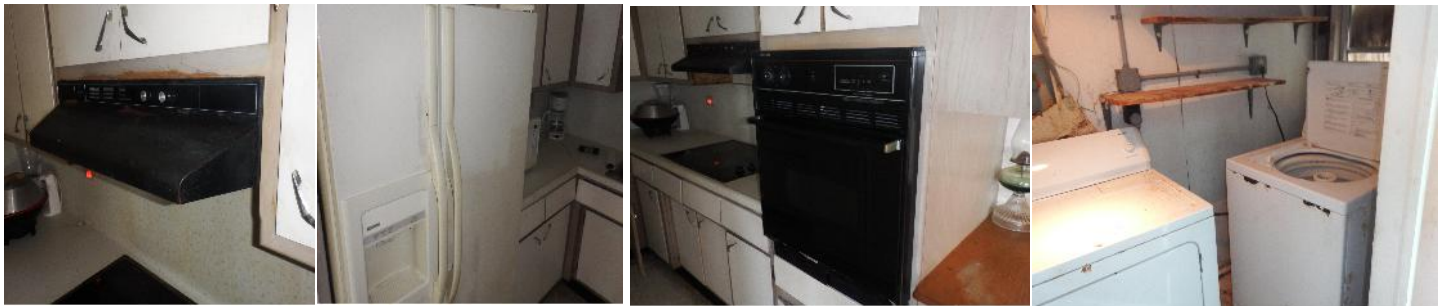
Appliances are nearing end of life cycle.

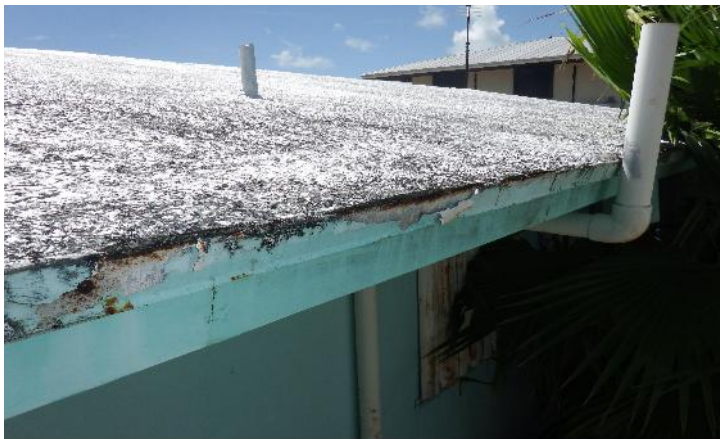
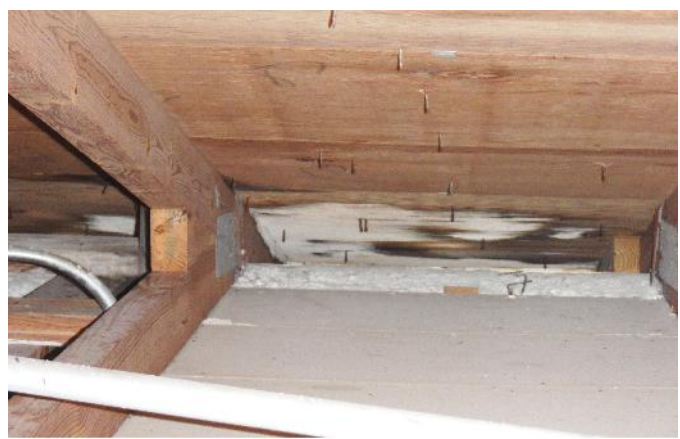
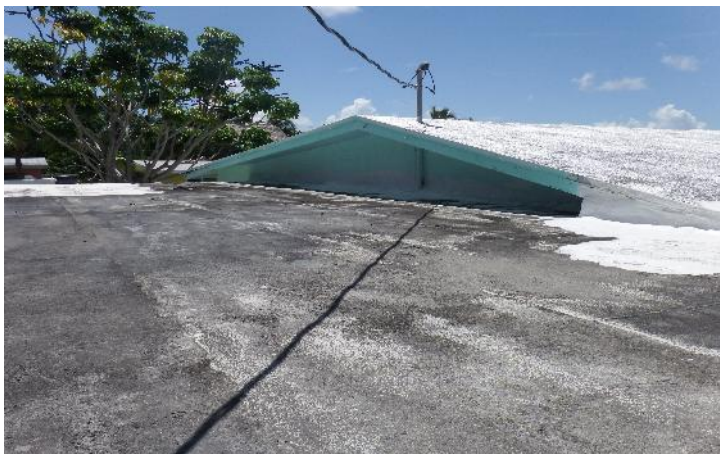
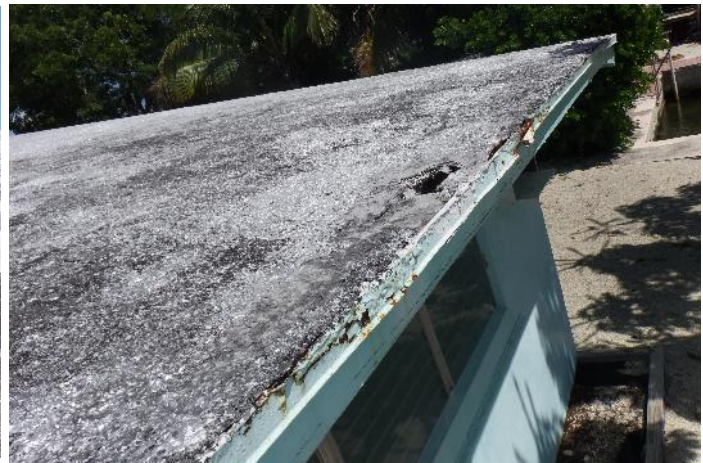
It should be noted that the drip edge was rusty and in need of maintenance.

There were some water stains on the sheeting in the attic over the soffit area.

There was in a hole in the flat roof over the storage area near the edge of the roof.

I recommend that flat roof be coated with a quality roof coating to maintain the integrity of the roof.

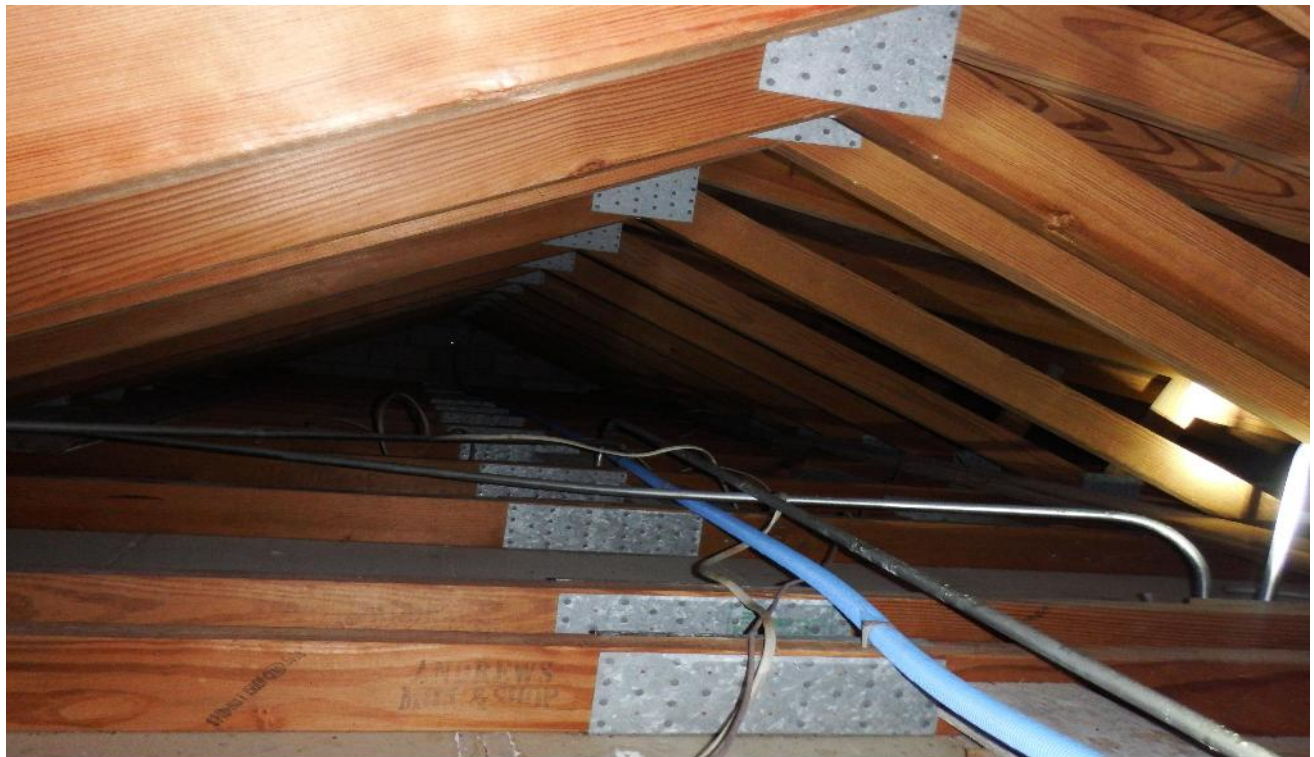
ACCESS	TYPE: Scuttle hole	OBSERVED: Via ladder	CONDITION: Satisfactory
STORAGE	FLOOR: Not floored		
INSULATION	TYPE: None	CONDITION:	
	AVERAGE INCHES:	APPROXIMATE R RATING:	
	INSTALLED IN:		
VENTILATION	TYPE: Soffit vents		
REMARKS: The attic was in satisfactory condition.
